**Apartment Building**  
New England  
2008

Investigation:  
Water Intrusion

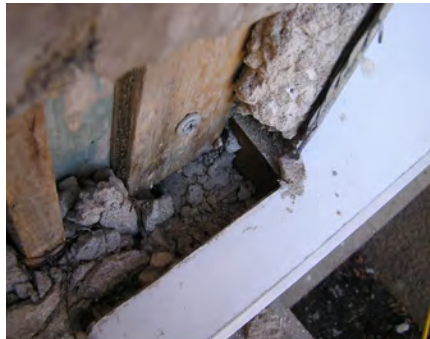
The apartment building, built around 1900 as a church, is a wood-framed stucco building that had been converted to an affordable multi-family apartment building in 1992. BSC was retained by the owner to investigate evidence of water damage - cracking of stucco around the replacement windows and peeling of paint on some facades - that had occurred since the conversion. Using on-site investigation of cladding details, review of the original construction drawings, and discussions with the owners about the history of the building, BSC analyzed the building enclosure and window details for problems with water intrusion. The analysis showed that while there was no major structural damage, there was potential for recurring problems because of water infiltration in certain areas and because of the failure to provide adequate drainage once water was behind the cladding. Details for recommended repairs were developed for each of the following areas: drainage for stucco cladding; flashing and sealant at the horizontal trim band; retrofitting of the replacement window details; better water management detail at the eave, and repair of paint. In most cases, a series of options - from less to more extensive - were provided with the benefits and disadvantages of each explained. BSC provided field inspection during the repairs.
