Health Care Center Midwest 2009

Investigation:
Exterior Water Damage

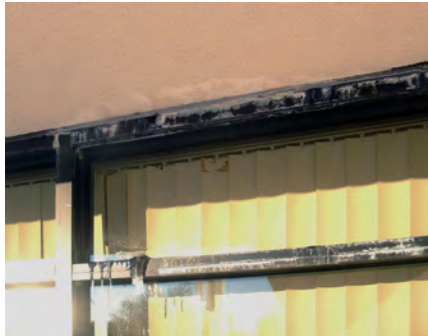
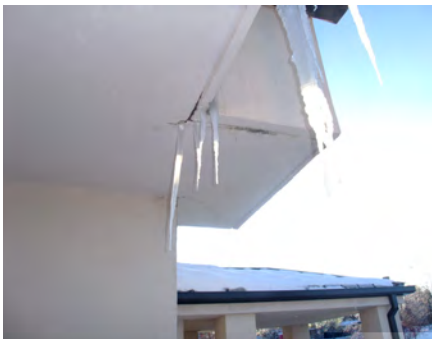
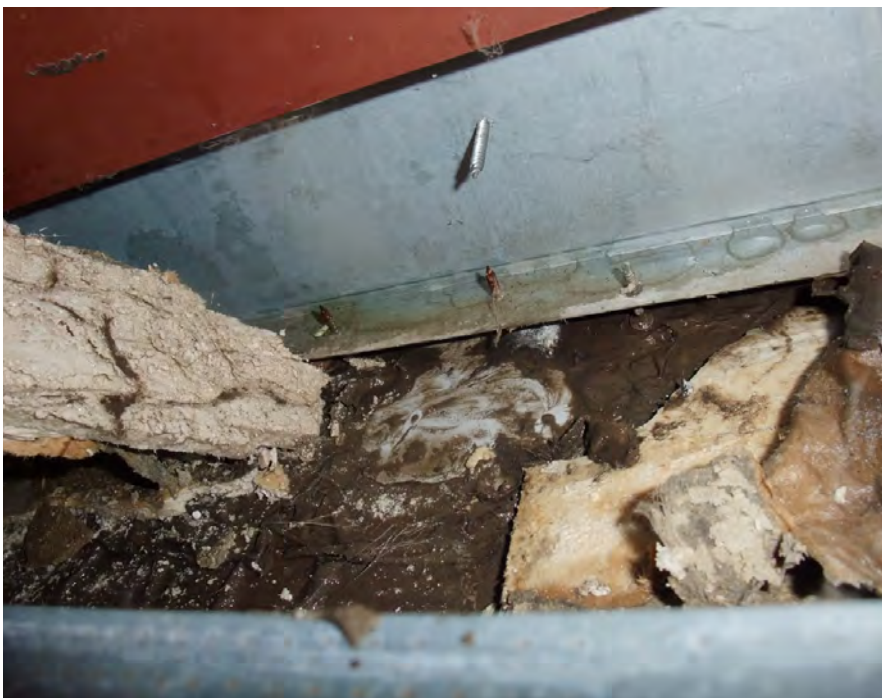
BSC performed a field investigation on moisture problems at a one-story, steel-stud building with EIFS walls, and soffit/fascia covered by a standing seam roof system. In cold weather, icicles were forming at cracks in the soffit and there were water stains on the exterior of the windows just below the soffit. It was observed that the space within the soffit was conditioned volume that was directly connected to the interior and, as is typical of a medical building, it was pressurized. This situation would result in substantial exfiltration through any air barrier gaps. A 3/8" gap in the air barrier was found along the fascia of the metal roof where sheathing indicated in the construction drawings had been omitted. This gap occurred consistently around the entire perimeter of the building. In addition, no insulation was provided at the fascia and return of the metal roof. With the humid conditioned air being pushed into the soffit because of the gap in the air barrier, condensation and even frost would consistently form there during cold weather causing the observed problems. BSC's final report provided step-by-step repair details to correct the deficiencies; BSC has continued to work with the project team, providing additional feedback and guidance during the repair process.
