## Indoor Pool Enclosure

New England  
2009

Investigation:  
Condensation Damage

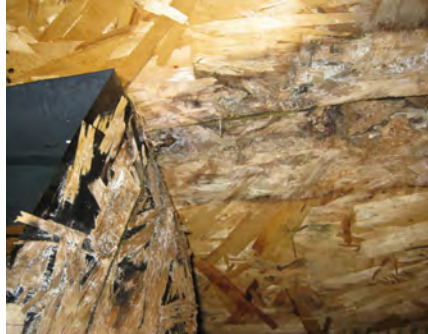
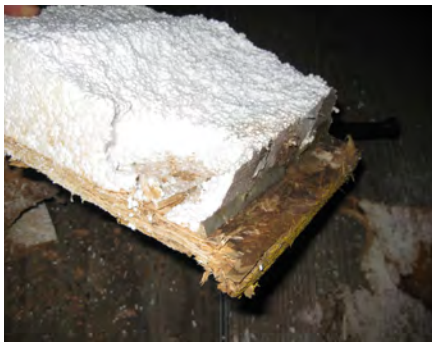
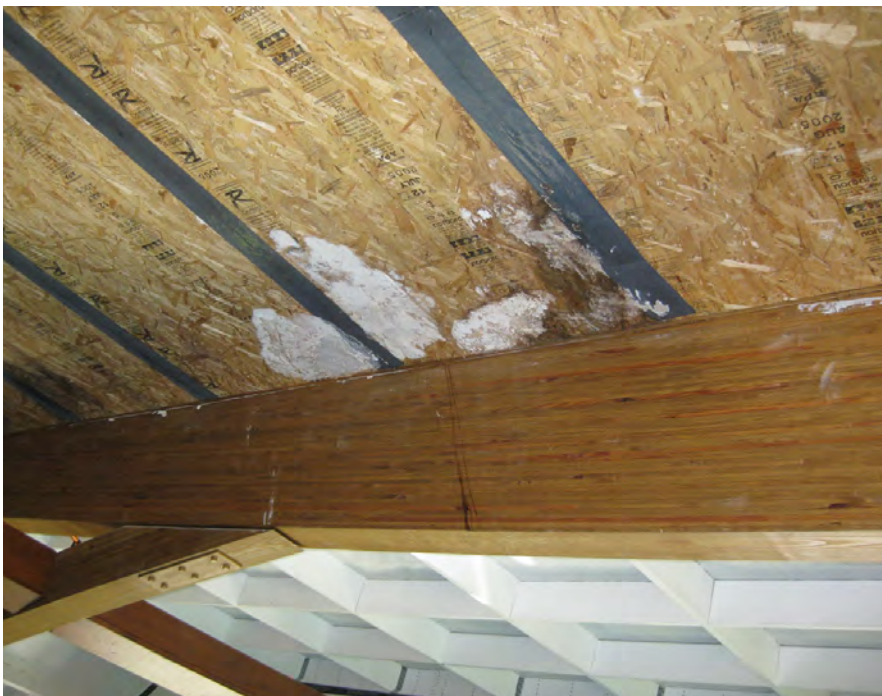
BSC was asked to investigate moisture accumulation concerns of an indoor pool located in the New England mountains. The building is designed with exposed glulam beams supporting a SIPs roof assembly. The assembly is covered with a standing seam metal roof. The walls are wood frame with exterior insulation covered by wood siding. Through intrusive investigation, considerable damage due to condensation was revealed at the panel joints of the SIP roof system. BSC's investigation showed that inadequate sealing of the joints of the roof SIP panels was allowing a path of the humid pool air to infiltrate into the spaces between the panels and condense on the underside of the roof sheathing. The condensate would drip back down into the panel joints resulting in deterioration of the interior OSB panel facer. BSC prepared a set of details showing how to repair or correct the deficiencies during the rehabilitation.
