Residential Development Gulf Coast 2009

Investigation:
Tile Floor Failure

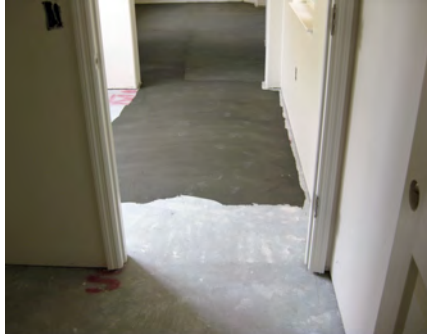
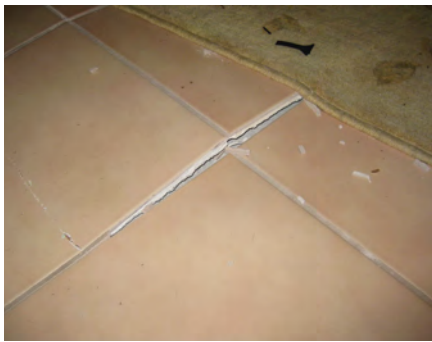
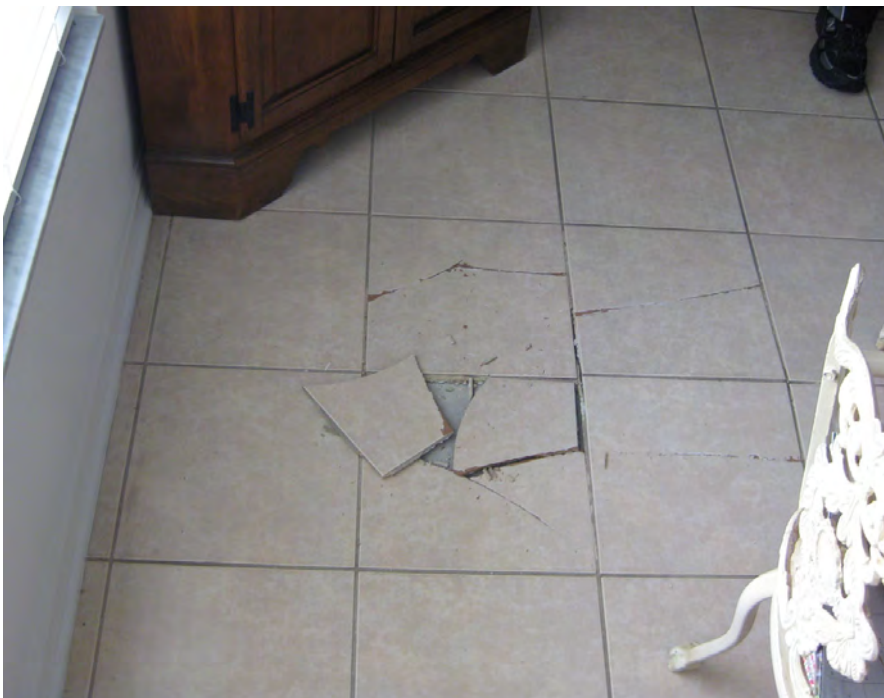
BSC was retained by a developer to investigate problems of tile flooring buckling and cracking in six homes of a large residential development. BSC's investigation included on-site investigation of the failures, review of construction processes, review of product manufacturers investigation reports, and a product literature review. The problems identified were due to expansion stresses resulting in the de-bonding of the tile isolation membrane from the concrete floor slabs. Given the small percentage of homes with these failures, BSC noted that this was not indicative of a systemic problem due to design, regional climate factors, or product use. Earlier reports suggested that high moisture emissions measured at the failed slabs were a possible cause for the failure, so BSC checked for distinguishing landscaping, drainage, or soil conditions at the affected homes that might cause this, but found none. Furthermore, BSC pointed out that the current moisture content would be the result of the subsequent impermeable floor cover and did not reflect the original condition of the slab when the membrane was installed. BSC concluded that the cause of failure was specific batch defects of the membrane product or contamination on the slab at the time that the membrane was applied. BSC's final report recommended replacement and repair methods to correct or mitigate these conditions as well as suggesting further investigation that could be done.
