Private Residence 2

New England
2009

Investigation:
Window Frame Decay

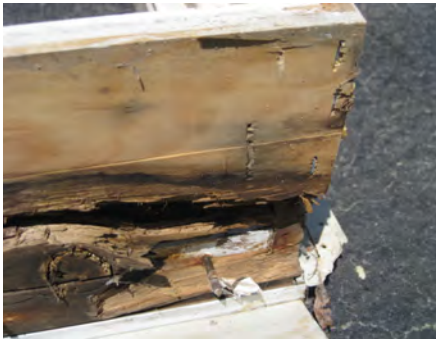
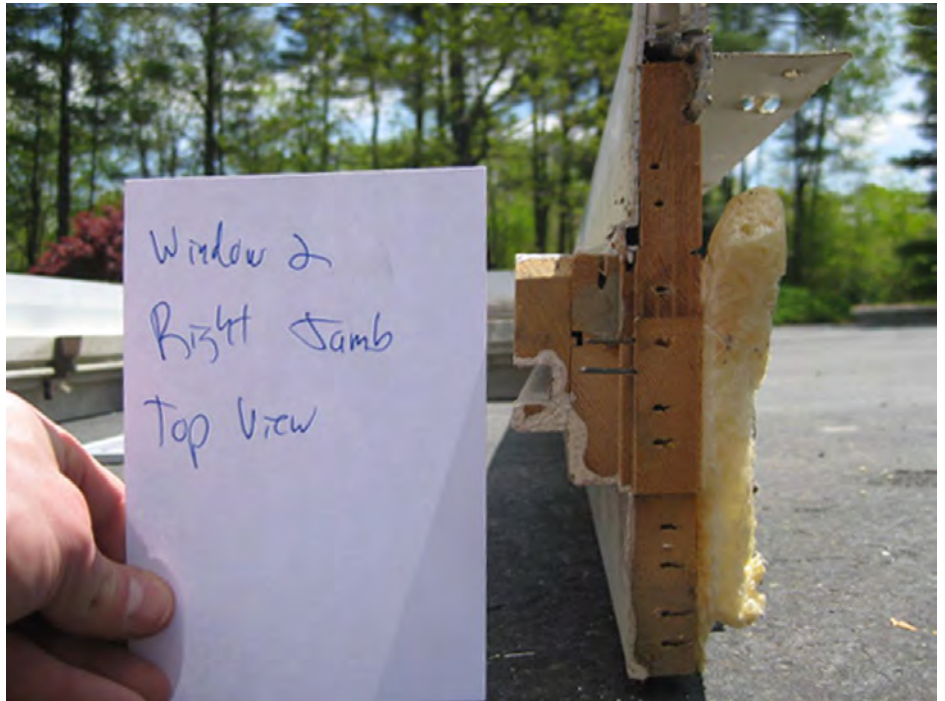
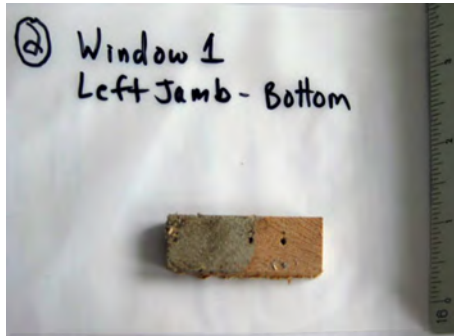
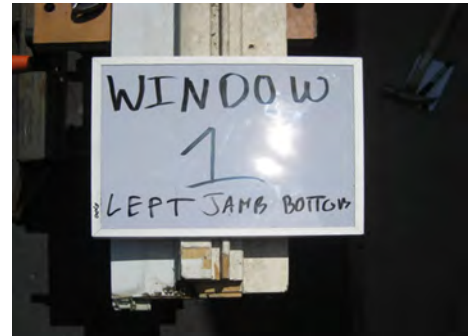
The owner of a home located in New England noticed that the wood frames on a number of the windows in the home had decayed. The windows, which had been installed approximately 20 years earlier, were aluminum clad windows from a reputable window manufacturer. The window manufacturer asked BSC to assist in determining whether the wood used in the windows had been appropriately treated with a preservative. Working with a test laboratory, BSC developed a protocol to be used for collecting samples of the wood to be tested for the presence of a preservative. Samples of wood from the windows along with samples of the same species of wood known not to be treated were submitted to the test laboratory. Testing was performed using neutron activation testing to determine whether a fungicide was present in the samples.
