**Apartment Building**  
New England  
2008

Investigation:  
Water Intrusion

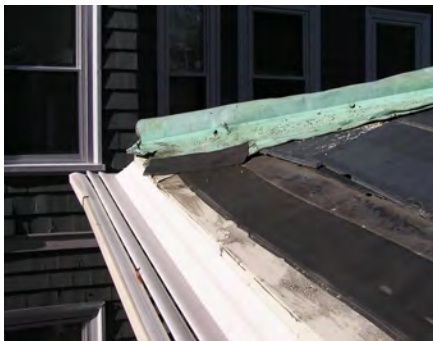
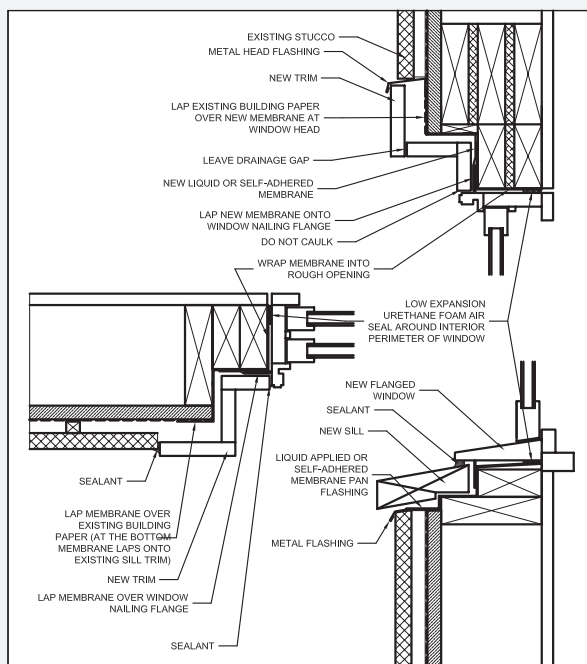
The apartment building, built around 1900 as a church, is a wood-framed stucco building that had been converted to an affordable multi-family apartment building in 1992. BSC was retained by the owner to investigate evidence of water damage - cracking of stucco around the replacement windows and peeling of paint on some facades - that had occurred since the conversion. Using on-site investigation of cladding details, review of the original construction drawings, and discussions with the owners about the history of the building, BSC analyzed the building enclosure and window details for problems with water intrusion. The analysis showed that while there was no major structural damage, there was potential for recurring problems because of water infiltration in certain areas and because of the failure to provide adequate drainage once water was behind the cladding. Details for recommended repairs were developed for each of the following areas: drainage for stucco cladding; flashing and sealant at the horizontal trim band; retrofitting of the replacement window details; better water management detail at the eave, and repair of paint. In most cases, a series of options - from less to more extensive - were provided with the benefits and disadvantages of each explained. BSC provided field inspection during the repairs.
